Hollow Stabilization Summer 2007 Report 1, 15 August 2007

by Architectural Historian & Local Project Manager Cheryl Hanback Shepherd

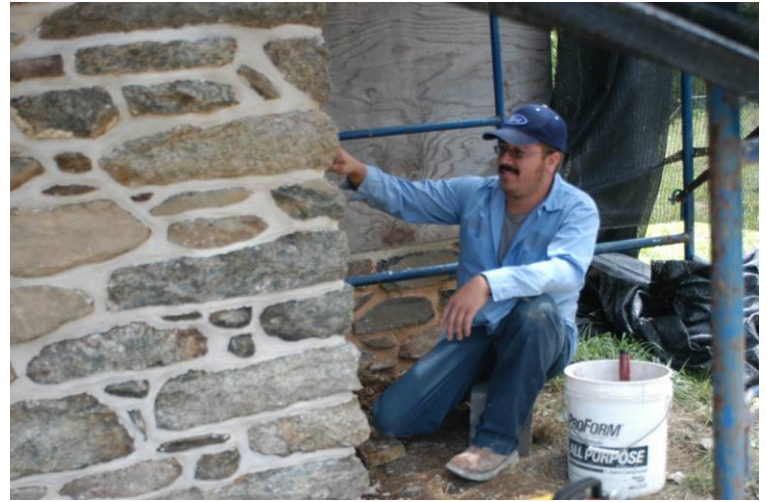
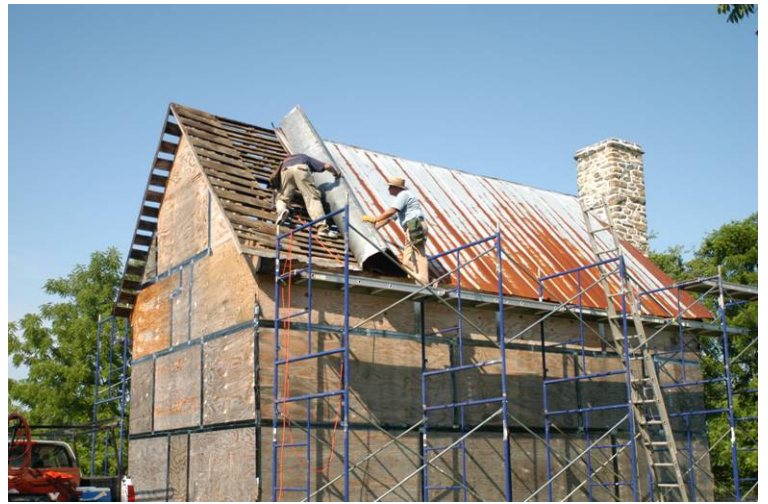
The slippage in the roof before leveling is visible on the left. However, the restored chimney rises straight. The wide, short sheathing on the ends of the gable dates to circa 1980 when the Friends of The Hollow decided an overhang would provide more protection for the weatherboards. Karl and Mike are pulling the strap taunt in the northwest corner of the garret. The knee wall was temporarily removed to lessen the tension on the framing. It was reattached with the original wrought nails.

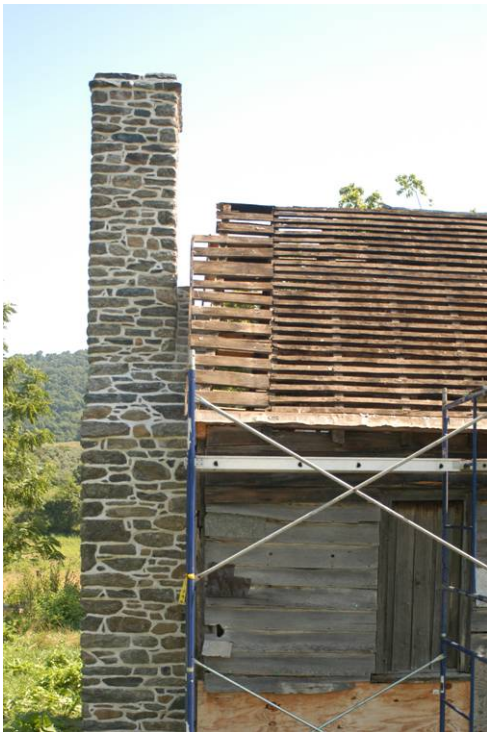
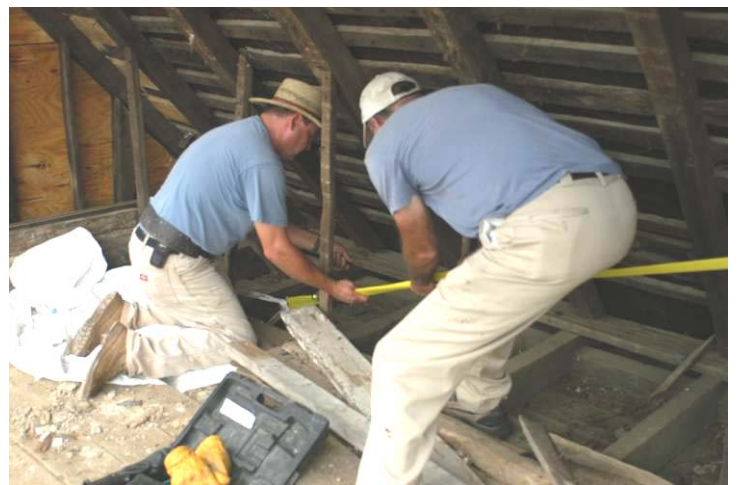
Seated on the scaffolding in the picture to the right, Karl is using consolidates to fill in deteriorated parts of the false or raising plate and rafter tails. This south false plate was too badly split to save entirely and had to be spliced at the east end. The rafter tails attach to this plate. John straddles the ridge to cut off the overhanging lath. Wider than traditional roofing lath, the bottom horizontal board at the eave is called the shingle starting board. The one on the north rear was deteriorated, recycled, poplar with a beaded edge. Both were replaced with solid oak boards, so the carpenters could start shingling on a solid base.

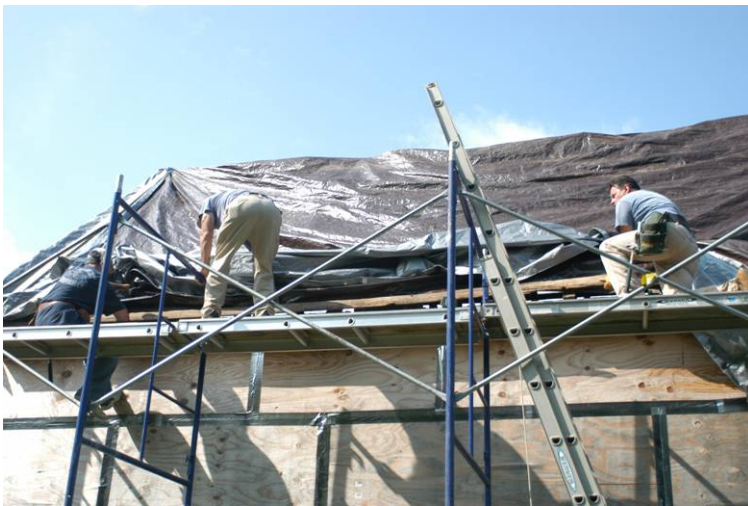
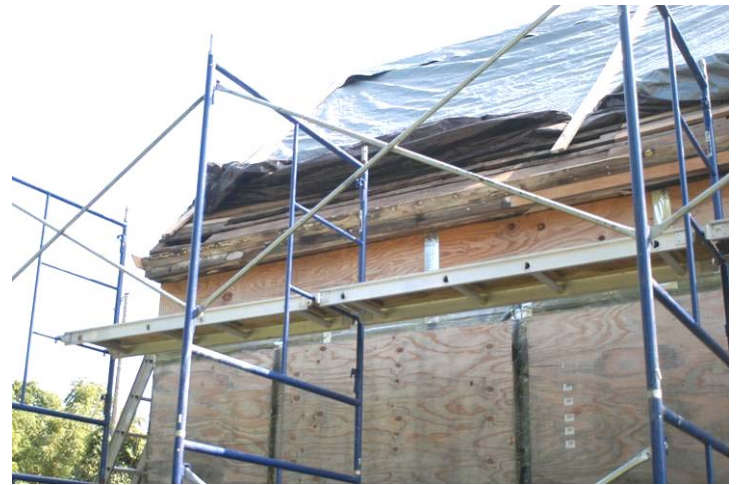
John, Mike and Karl are pulling up the 15'-1/2" foot-long poplar starting board on the north rear roof slope that had two rose-head nails fastening it. A half-inch bead finished the board, indicative of a possible trim band under a cornice. The original boxed cornice above and left display the use of Abatron and West System wood consolidation products to preserve as much of the materials as possible. New timber is spliced in to the west-right end of the cornice which was largely destroyed by carpenter bees, water and rot.

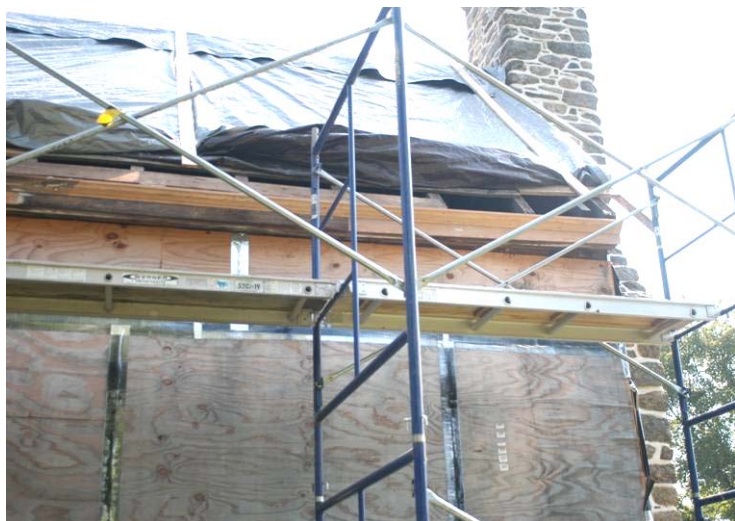
Here's the front elevation with the cornice and starting board restored. It's the first time the team has seen a cornice on the front. Notice that even with the tarp on the roof, the racking no longer appears. Likewise, the body of the dwelling stands proudly erect since its straightening and stabilization involving lifting, inserting a new sill, patching framing and foundation work in 2005.

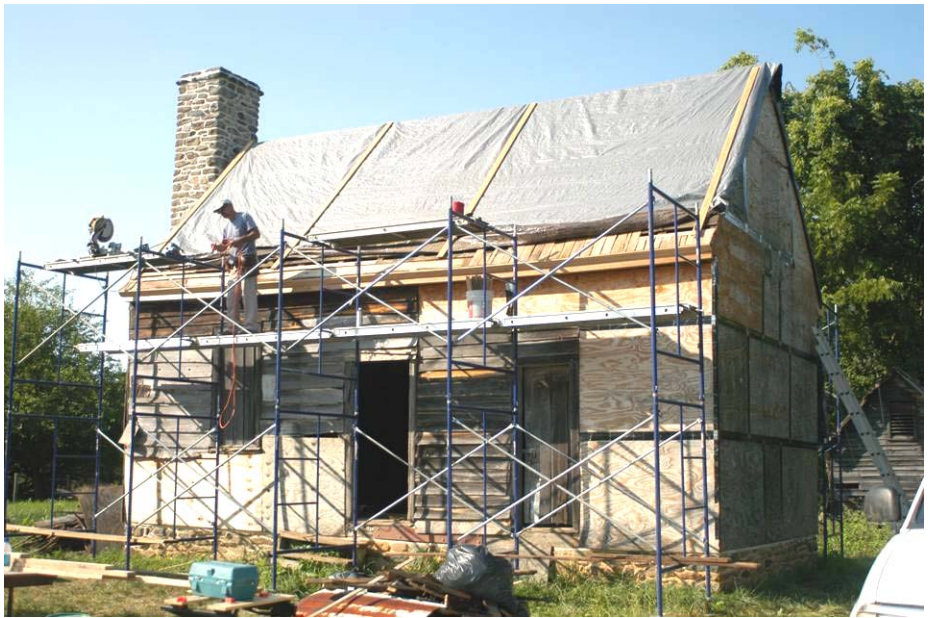
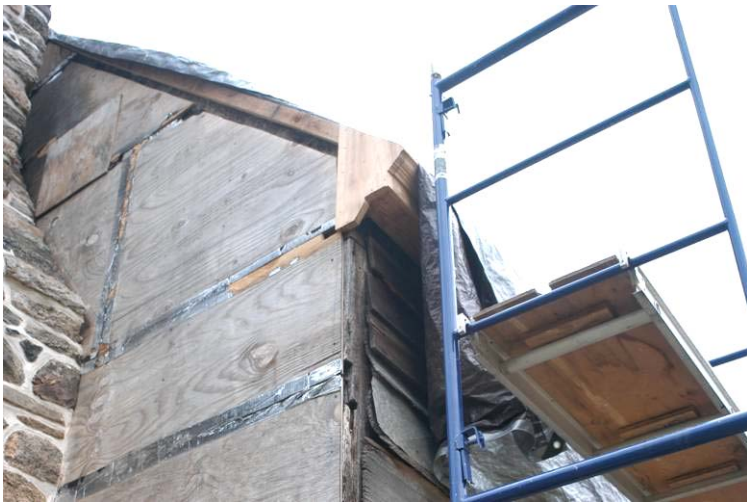
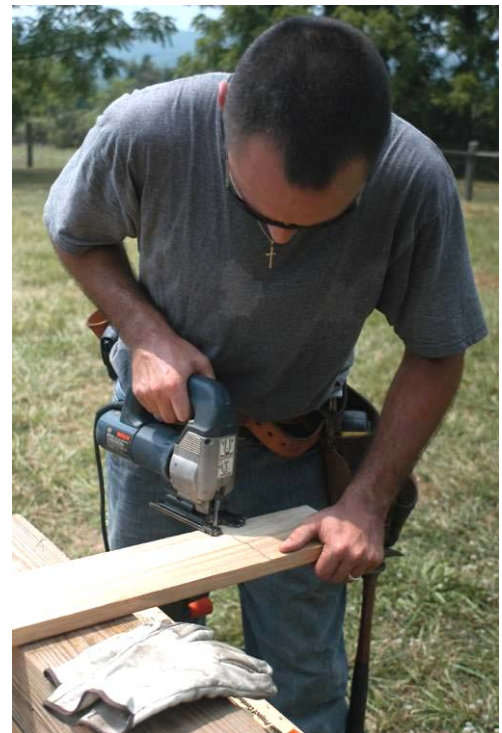
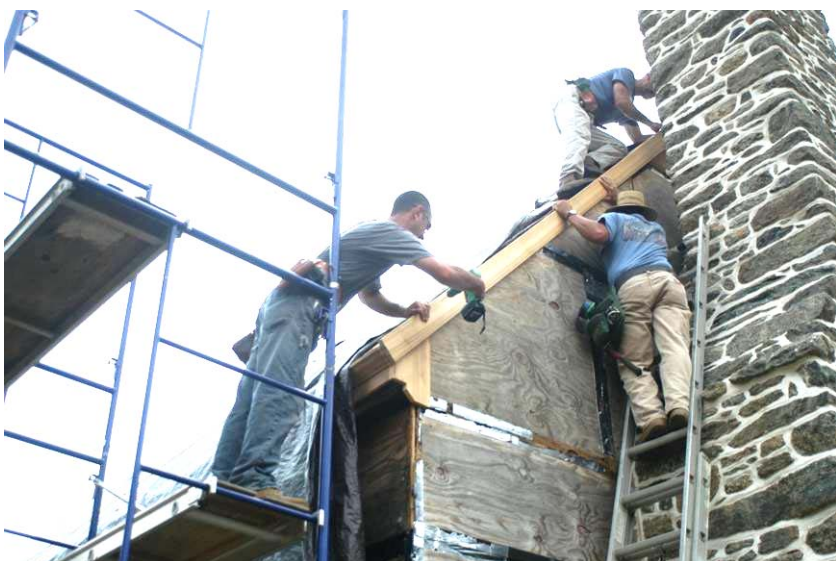
John has drawn the crown molding profile on the poplar rake board for the northwest slope of the gable and is cutting the pattern with a modern jigsaw. At left, John, Karl and Mike together fasten the rake board. Room still remains underneath to remove the protective plywood and apply the weatherboard later. Because the rakes came warped, Mike had to plane them after attachment to perfectly achieve the eighteenth-century characteristic taper to the ridge.

At right, Mike planes the northwest rake with Karl's assistance, and John begins tooling the rake end to match the cornice and end boards. The finished cornice, end trim and rake on the southwest front corner is shown below. Marshall descendants have long been embarrassed by the neglected appearance of the great Chief Justice John Marshall's one-and-one-half-story, frame, boyhood home. Yet, our years of evaluation have proven that the house was far from shameful when constructed. Now,

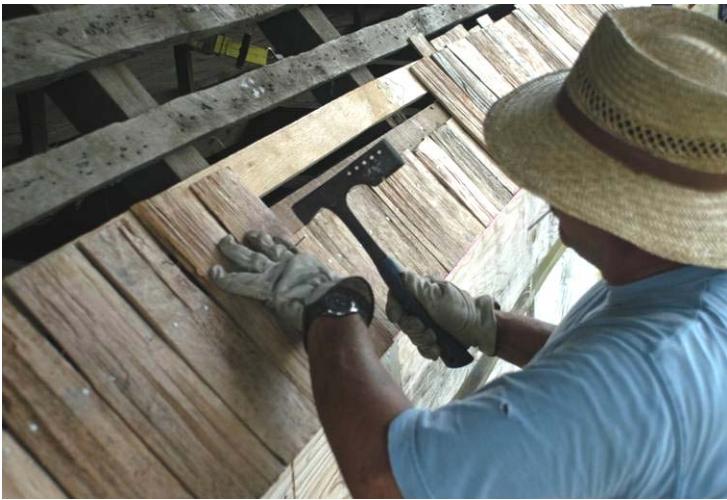
At left, Karl lays the twelve-inch-long second layer on the starter course, and Mike places one-and-one-half-inch marks on the middle course where he wants the overlay edge to fall.

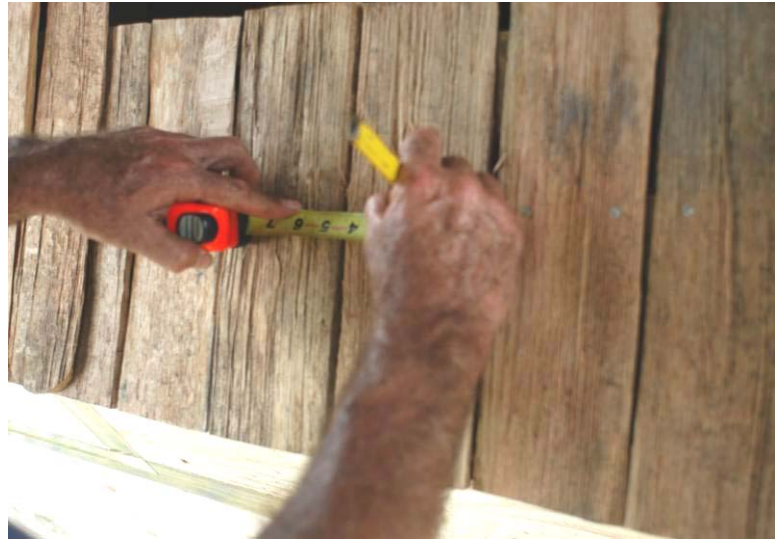
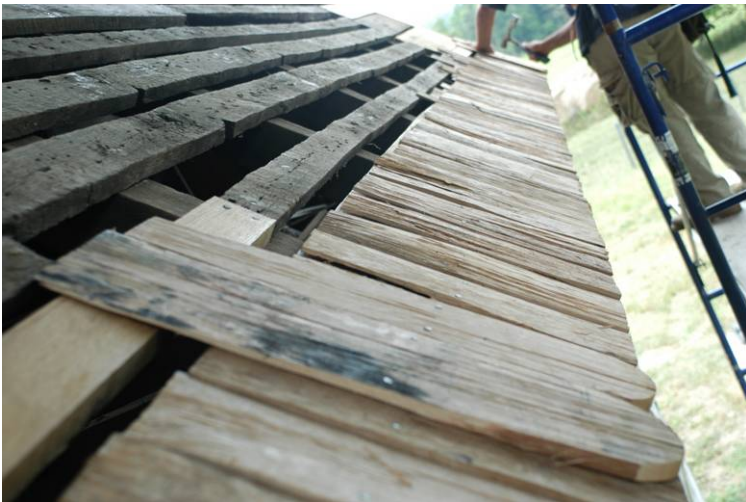
The eight- and twelve-inch starter shingles are set in the left picture, and Mike has applied two of the top shingles. His one-and-one-half-inch space shows on the middle shingle. The carpenters are leaving 1/8" to 1/4" between the shingles for breathing and swelling. With six courses fully attached in the lower photograph, the wood-shingled roof is taking on a colorful chronochromatic look in the shade and features Thomas Marshall's round-butt or scalloped pattern.
