# Flightfax

JUNE 1999 ♦ VOL 27 ♦ NO 6

**Tree  
strikes,  
you're  
out!**

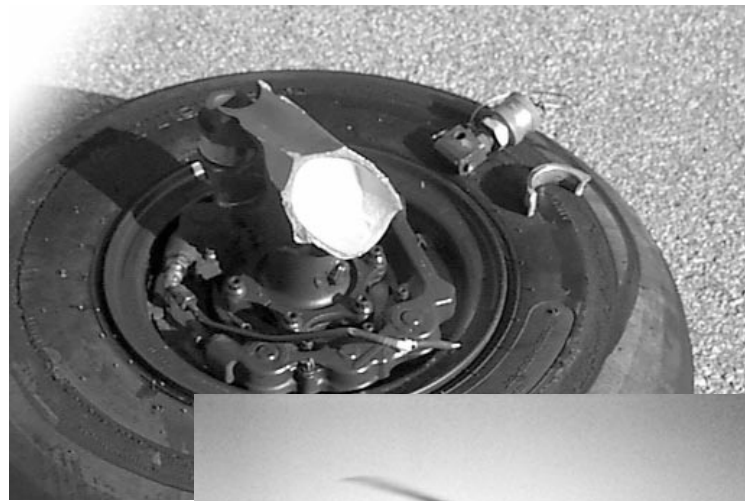
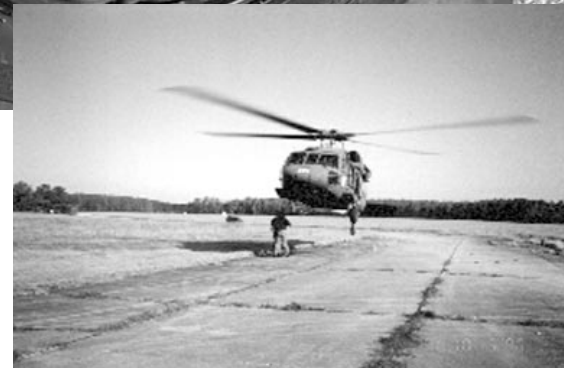
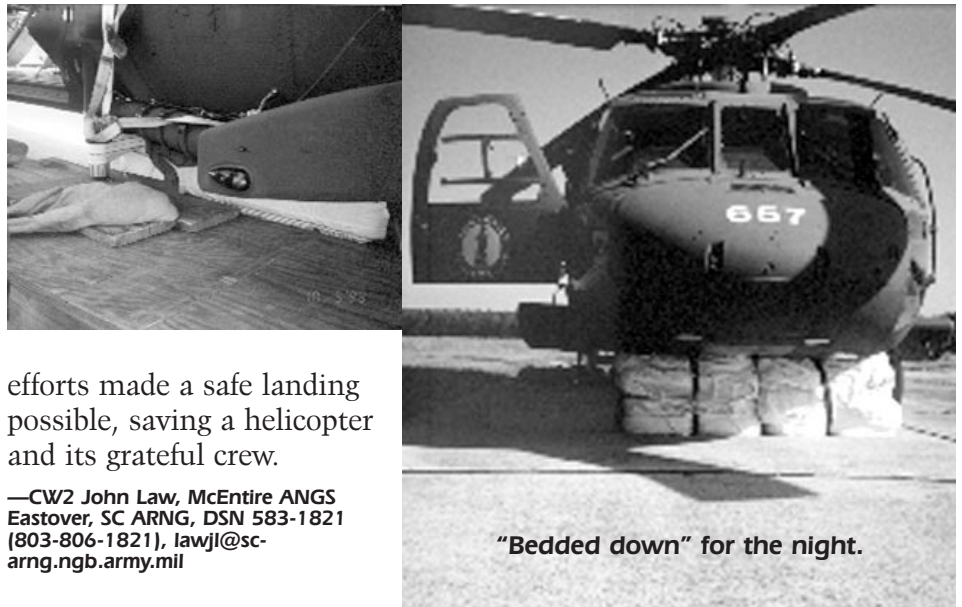
As the mains touch down following the tail wheel, you hear the sickening, unmistakable sound of a large metal structure letting go. The helicopter lurches down and to the right, with the main-rotor blades coming so close to the ground and the passengers that you instinctively hiss "OH SH--!"

Somehow you manage to return to a hover before the main rotor blades puree the approaching passengers. When asked if the right main tire has blown out, the crew chief informs you that the wheel is now lying on the pad with its severed drag beam and main strut end still attached.

As the photos show, this one had a happy ending. Chalk it up to teamwork and true crew coordination that extended to include the ground crew. Their

foot ICS cord through the gunner's window, enabling communications with ground personnel while hovering. The ground crew plans to assemble a platform consisting of C-5A loading ramps and a stack of bunk-bed mattresses.

**"Bedded down" for the night.**
