Hollow Stabilization Summer 2007 Report 1, 15 August 2007

by Architectural Historian & Local Project Manager Cheryl Hanback Shepherd

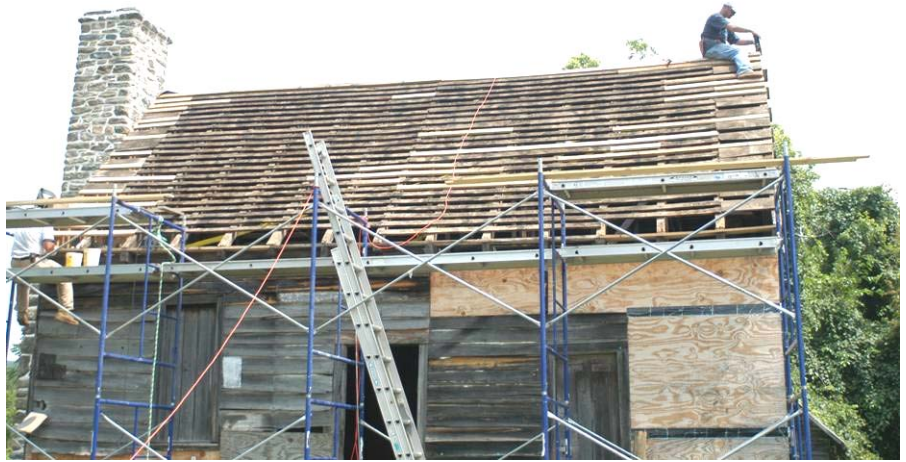
Seated on the scaffolding in the picture to the right, Karl is using consolidates to fill in deteriorated parts of the false or raising plate and rafter tails. This south false plate was too badly split to save entirely and had to be spliced at the east end. The rafter tails attach to this plate. John straddles the ridge to cut off the overhanging lath. Wider than traditional roofing lath, the bottom horizontal board at the eave is called the shingle starting board. The one on the north rear was deteriorated, recycled, poplar with a beaded edge. Both were replaced with solid oak boards, so the carpenters could start shingling on a solid base.

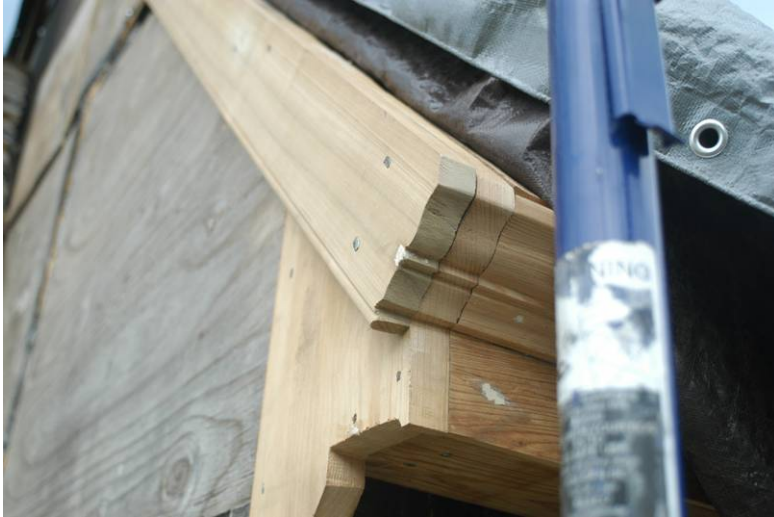
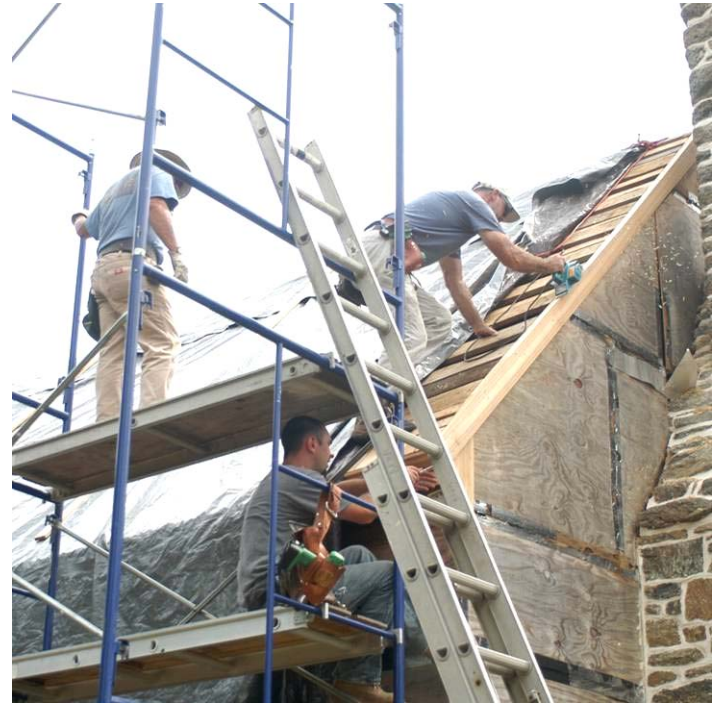
At right, Mike planes the northwest rake with Karl's assistance, and John begins tooling the rake end to match the cornice and end boards. The finished cornice, end trim and rake on the southwest front corner is shown below. Marshall descendants have long been embarrassed by the neglected appearance of the great Chief Justice John Marshall's one-and-one-half-story, frame, boyhood home. Yet, our years of evaluation have proven that the house was far from shameful when constructed. Now,

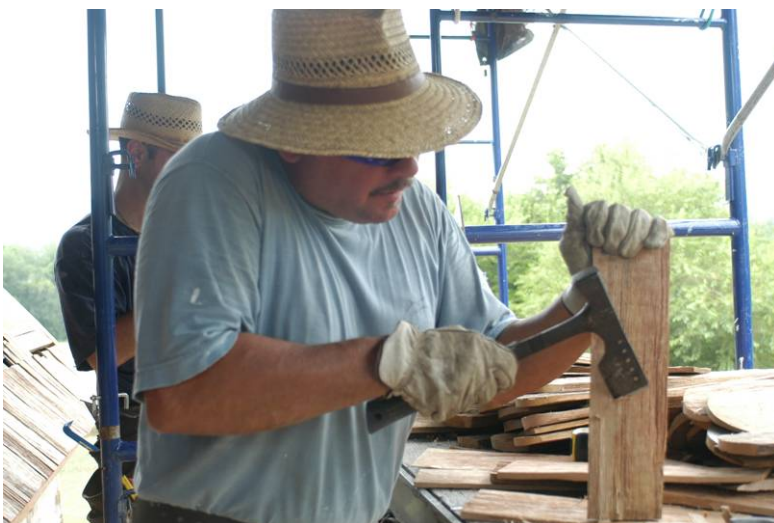
These APVA artisans are extremely particular to have a perfect fit for the longevity of the roof. Karl further planes a twelve-inch-long shingle. We are in the process of working with the cooperative supplier to improve the quality of shingles since more fail to meet superior standards in size, thickness and straightness with minimal flaws that Mike, Karl and John expect for traditional shingling.
